# **The Road Inventory of William L Finley National Wildlife Refuge Corvallis, OR**

Prepared By:  
Federal Highway Administration  
Central Federal Lands Highway Division  
February 2013

# William L Finley NWR - 13589

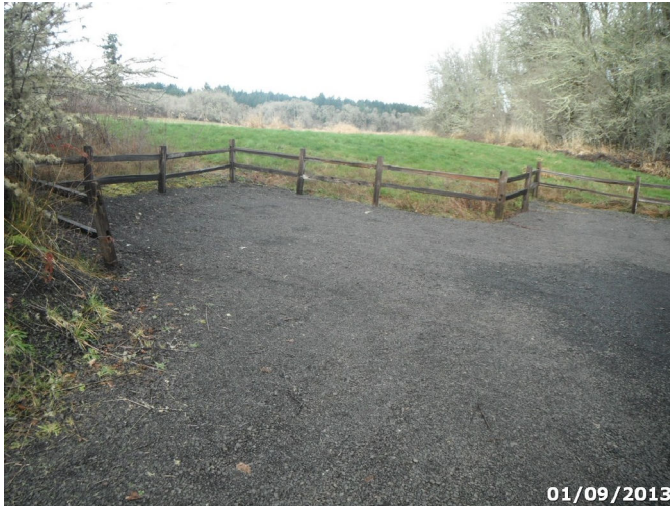
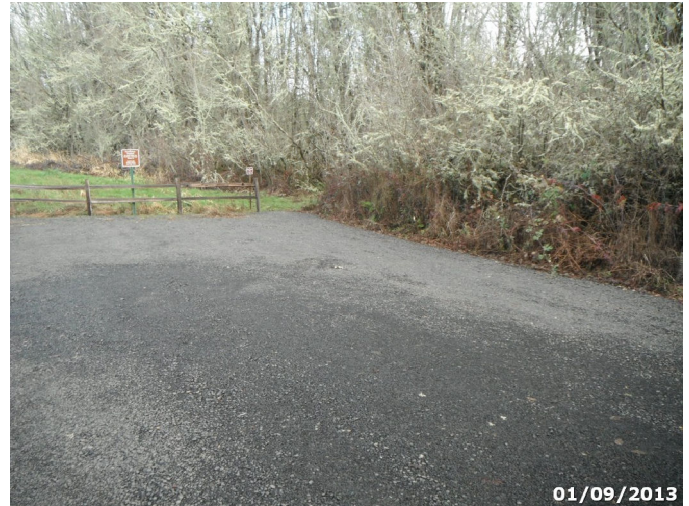
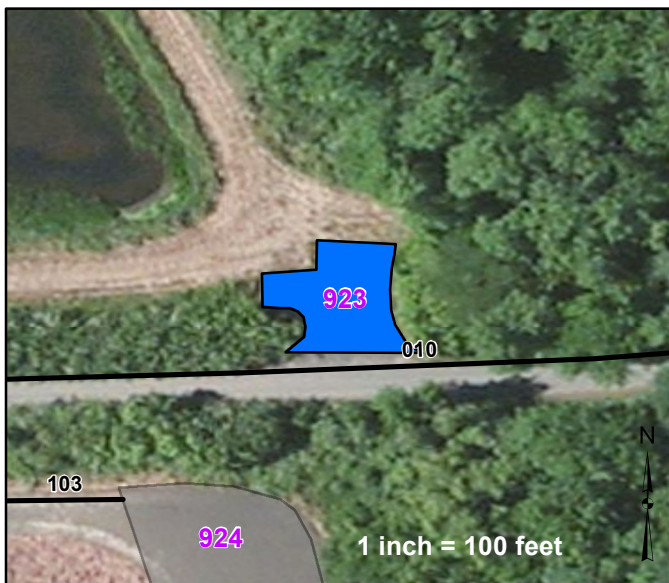
## Route Number: 923

Asset Number	Area (Sq Ft)	Spaces	Condition	Surface Type	Cost to Improve	Inspection Date	Current Replacement Value
-	2206	5	Excellent	Gravel	\$0	01-09-2013	\$12,500

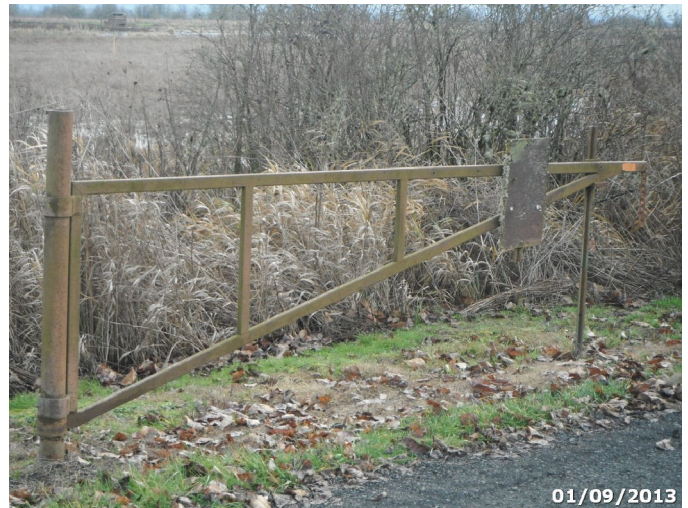
Photo: WIFI\_C4\_0271 Route: 010-001-0.01  
Metal Open Rail Gate

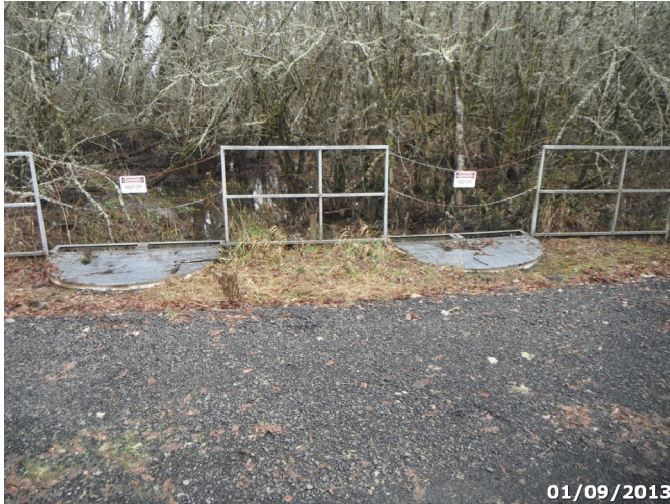
Photo: WIFI\_C4\_0276 Route: 010-001-0.63  
Metal WCS Flashboard Riser  
50ft long 48in dia. 2ft deep

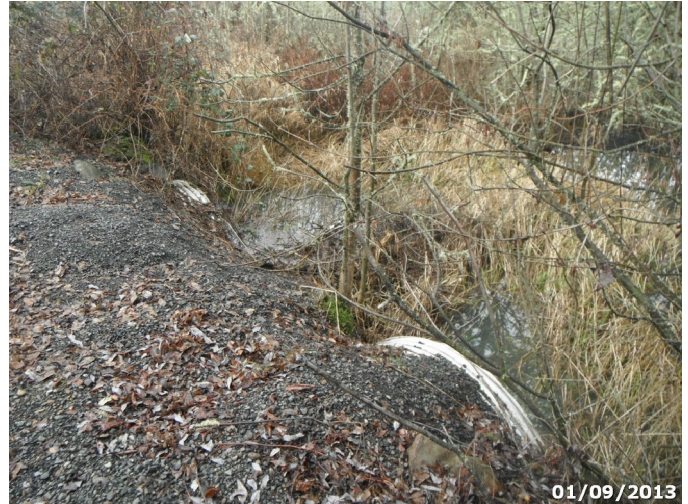
Photo: WIFI\_C4\_0277 Route: 010-001-0.63  
Metal WCS Flashboard Riser  
50ft long 48in dia. 2ft deep

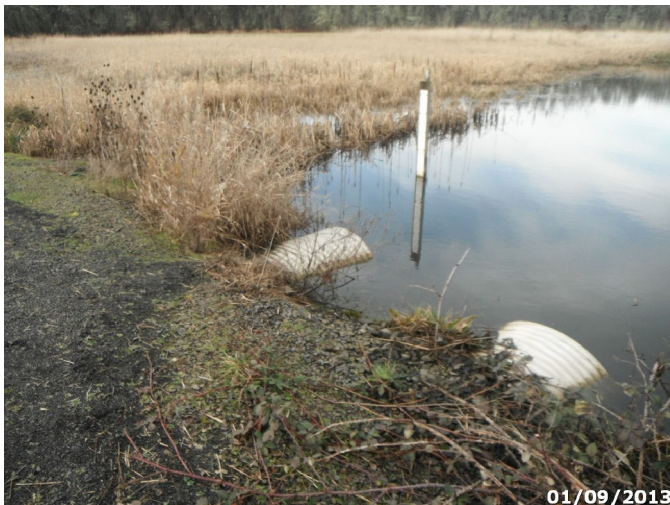
Photo: WIFI\_C4\_0293 Route: 010-001-0.98  
Metal Culvert 40ft long 48in dia. 1ft deep

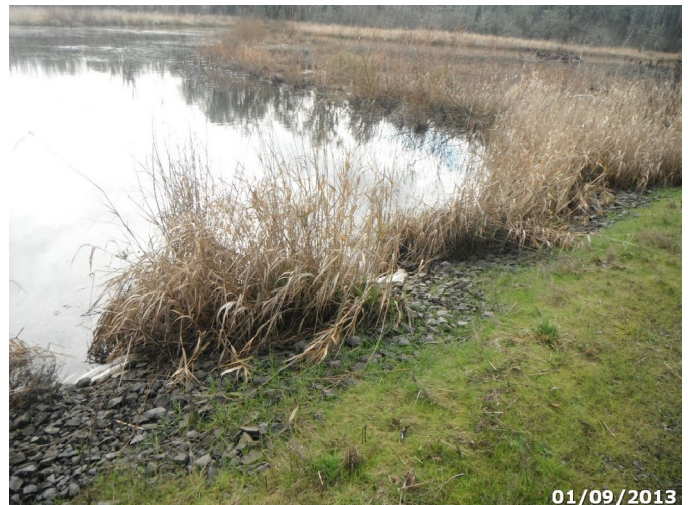
Photo: WIFI\_C4\_0294 Route: 010-001-0.98  
Metal Culvert 40ft long 48in dia. 1ft deep

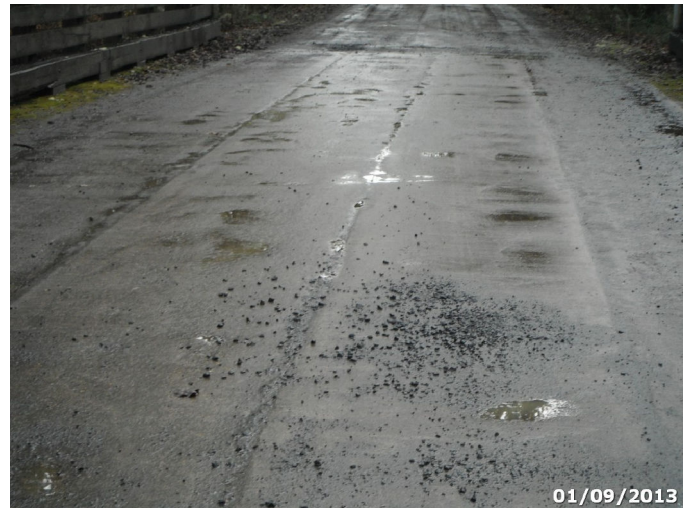
Photo: WIFI\_C4\_0296 Route: 010-002-1.18  
Concrete Bridge NBIS:000013589-0002  
MUDDY CREEK Asset# 10004453

William L Finley - 13589 Bridge Inventory					
Rte #	Milepost	NBIS #	Sufficiency Rating	Functionally Obsolete	Structurally Deficient
10	1.18	000013589-0002	950	N	N
104	0.03	000013589-0030	398	N	N

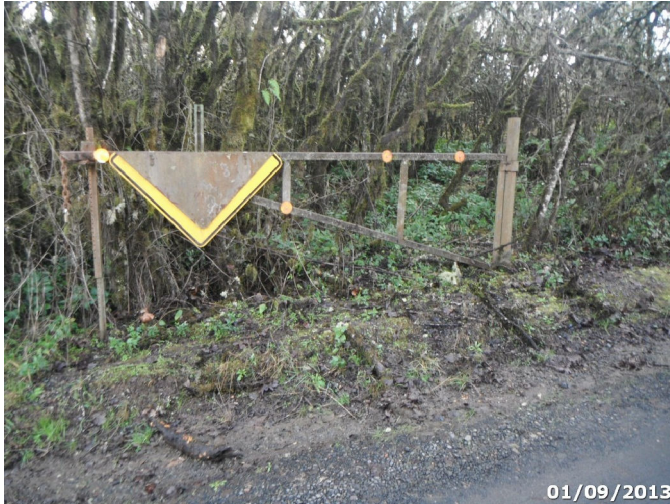
Photo: WIFI\_C4\_0304 Route: 010-002-1.43  
Metal Open Rail Gate

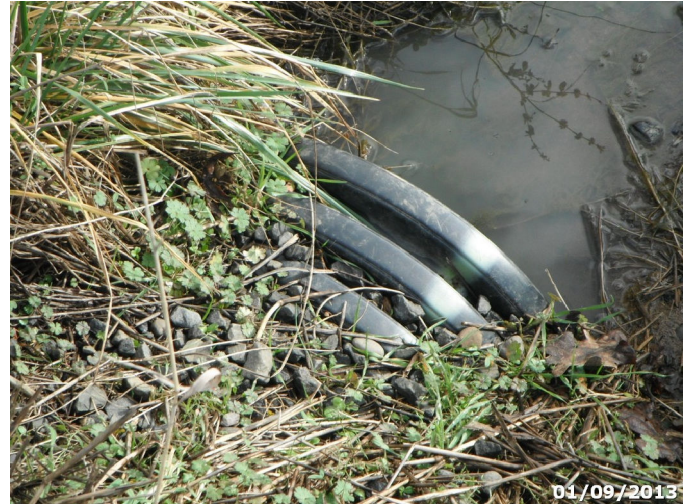
Photo: WIFI\_C4\_0311 Route: 010-002-1.67  
Plastic Culvert 25ft long 12in dia. 1ft deep

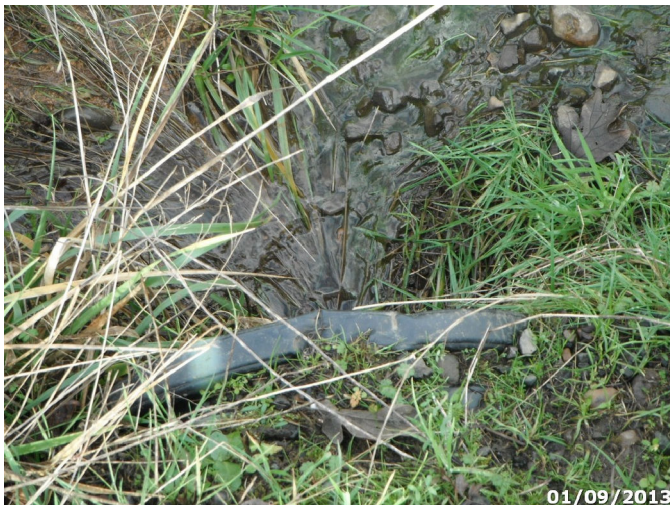
Photo: WIFI\_C4\_0312 Route: 010-002-1.67  
Plastic Culvert 25ft long 12in dia. 1ft deep

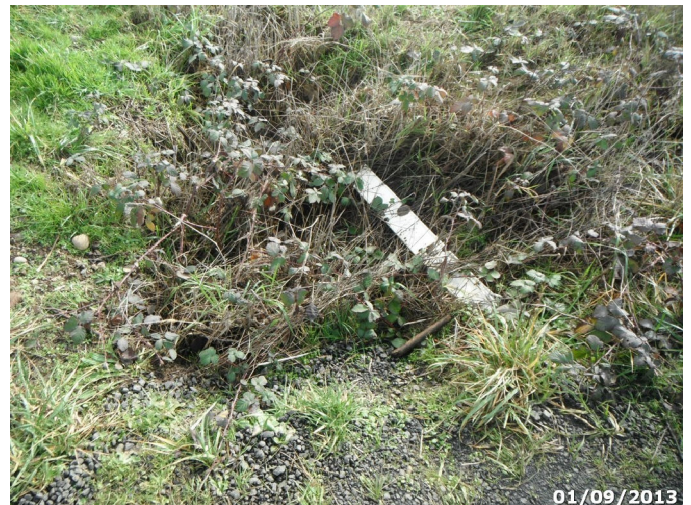
Photo: WIFI\_C4\_0315 Route: 010-002-1.8  
Plastic Culvert 25ft long 12in dia. 1ft deep

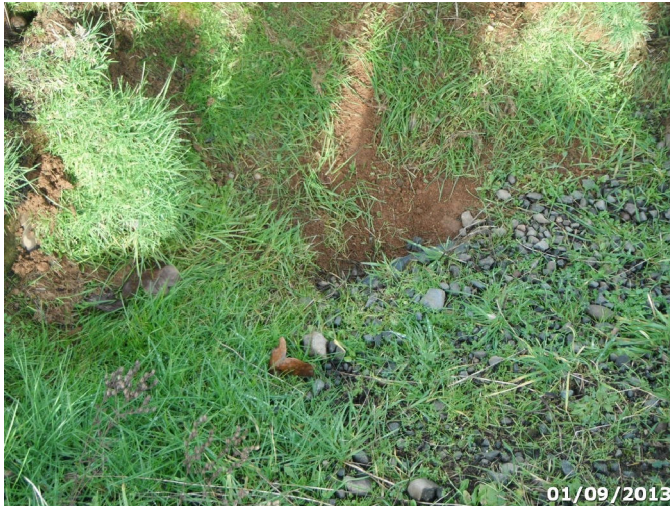
Photo: WIFI\_C4\_0316 Route: 010-002-1.8  
Plastic Culvert 25ft long 12in dia. 1ft deep

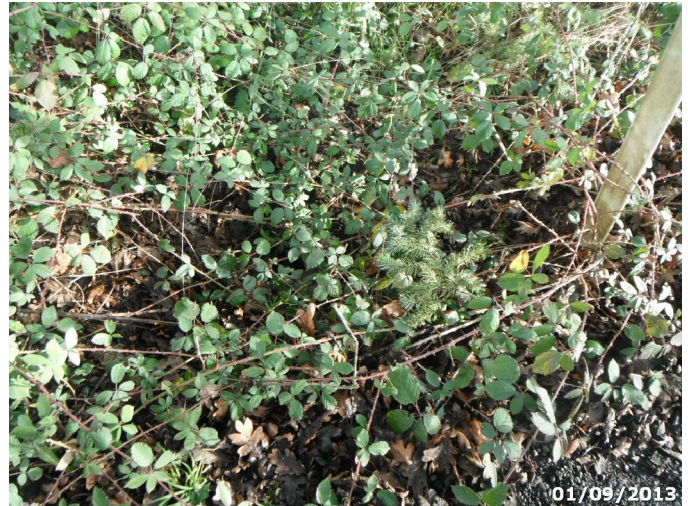
Photo: WIFI\_C4\_0317 Route: 010-002-1.96  
Plastic Culvert 25ft long 12in dia. 1ft deep

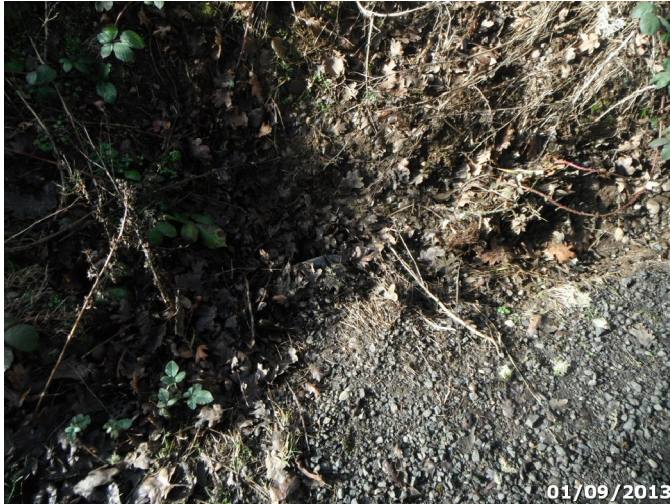
Photo: WIFI\_C4\_0318 Route: 010-002-1.96  
Plastic Culvert 25ft long 12in dia. 1ft deep

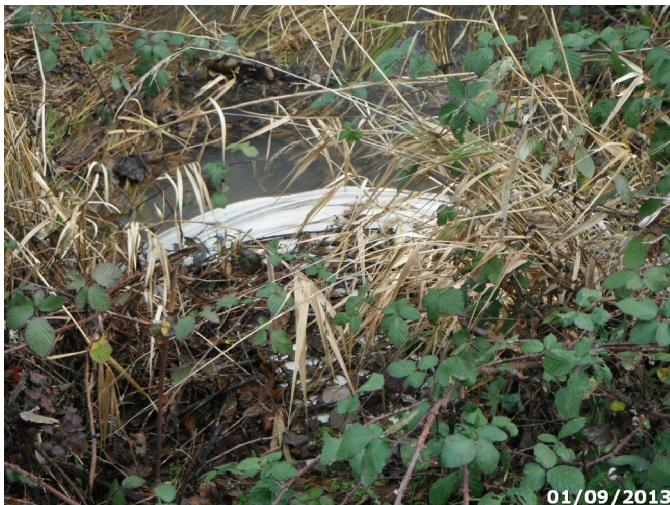
Photo: WIFI\_C4\_0325 Route: 010-003-2.14  
Metal WCS Flashboard Riser  
30ft long 48in dia. 2ft deep

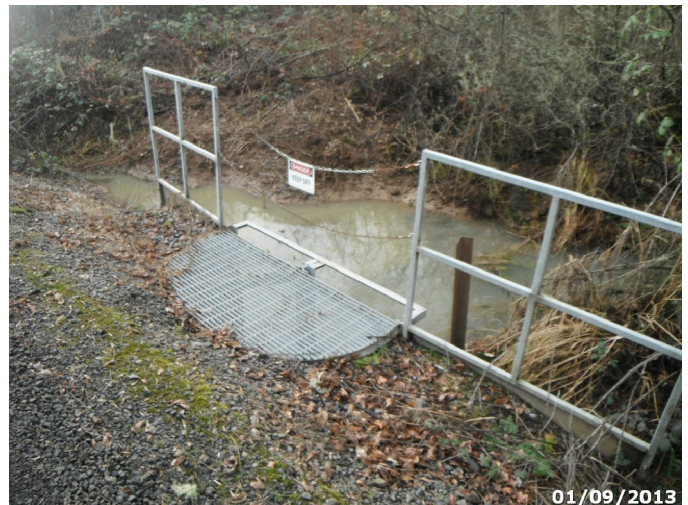
Photo: WIFI\_C4\_0326 Route: 010-003-2.14  
Metal WCS Flashboard Riser  
30ft long 48in dia. 2ft deep

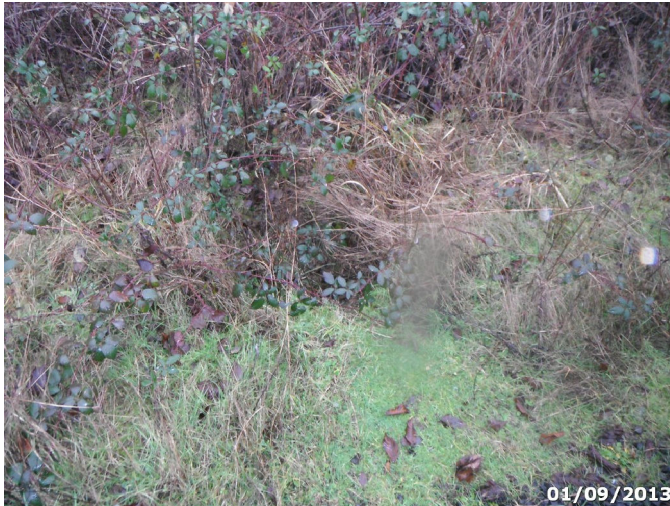
Photo: WIFI\_C4\_0341 Route: 010-003-2.7  
Plastic Culvert 25ft long 6in dia. 1ft deep

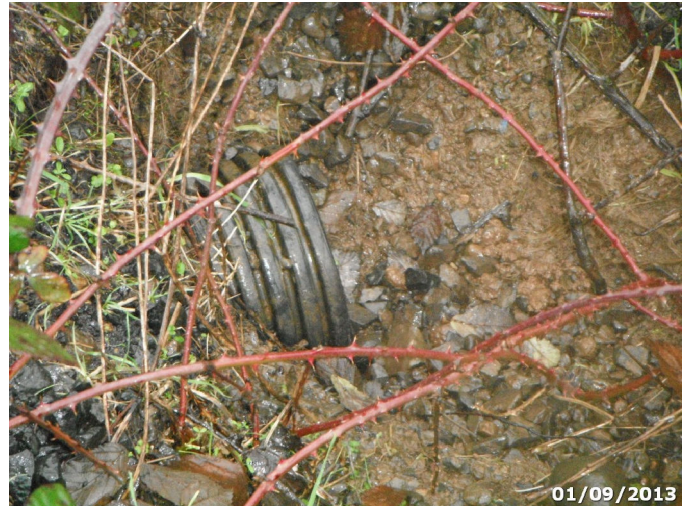
Photo: WIFI\_C4\_0342 Route: 010-003-2.7  
Plastic Culvert 25ft long 6in dia. 1ft deep

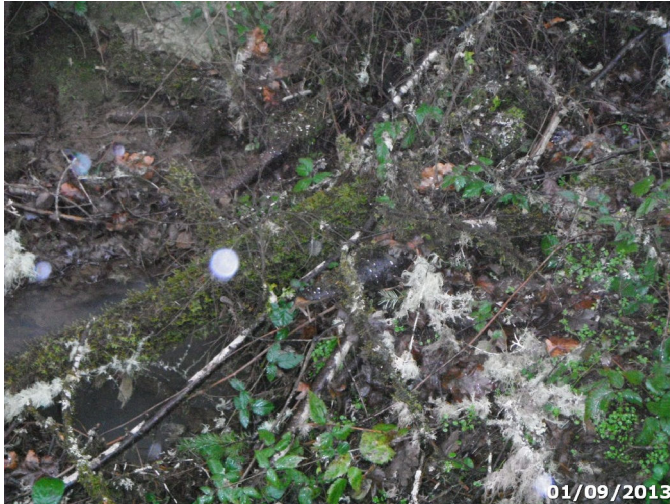
Photo: WIFI\_C4\_0343 Route: 010-003-2.77  
Plastic Culvert 30ft long 24in dia. 1ft deep

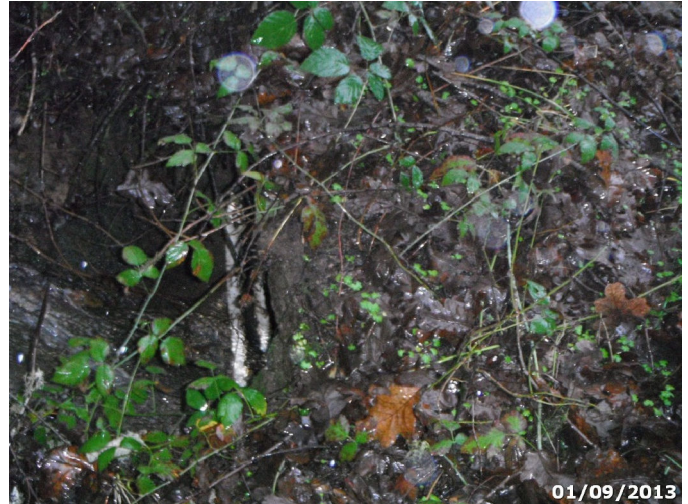
Photo: WIFI\_C4\_0344 Route: 010-003-2.77  
Plastic Culvert 30ft long 24in dia. 1ft deep

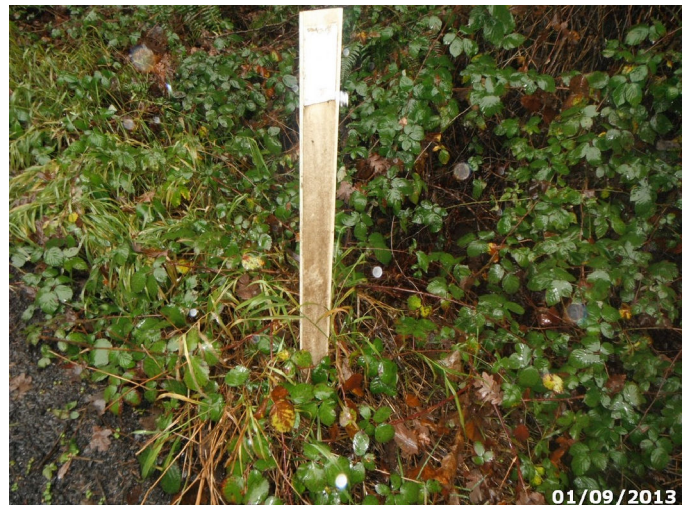
Photo: WIFI\_C4\_0346 Route: 010-004-3.06  
Plastic Culvert 30ft long 12in dia. 1ft deep

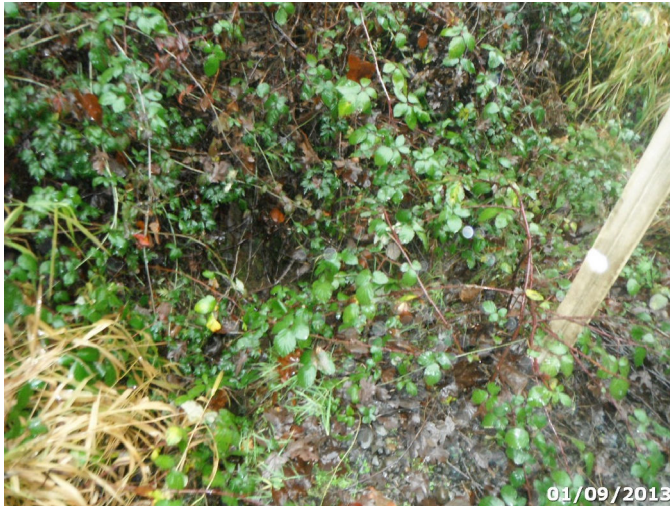
Photo: WIFI\_C4\_0347 Route: 010-004-3.06  
Plastic Culvert 30ft long 12in dia. 1ft deep

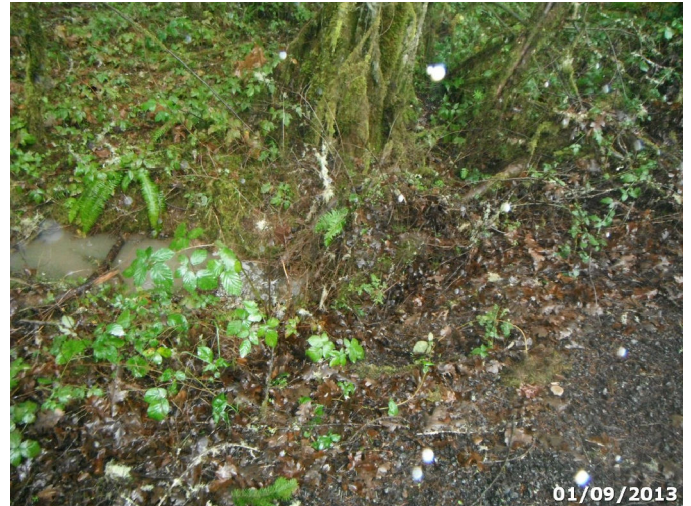
Photo: WIFI\_C4\_0348 Route: 010-004-3.08  
Metal Culvert 30ft long 24in dia. 2ft deep

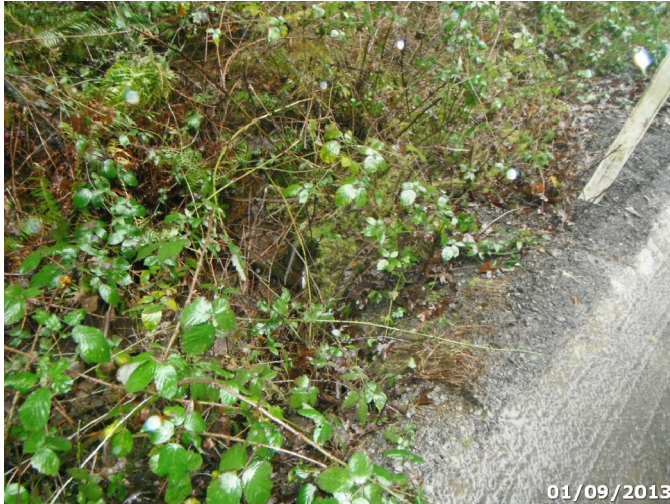
Photo: WIFI\_C4\_0349 Route: 010-004-3.08  
Metal Culvert 30ft long 24in dia. 2ft deep

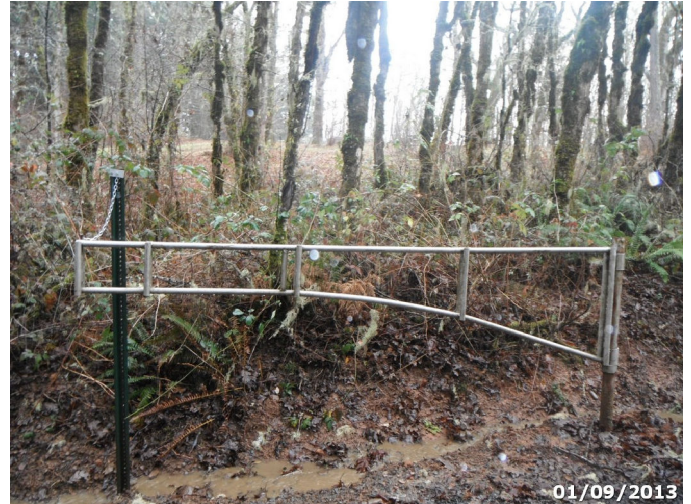
Photo: WIFI\_C4\_0350 Route: 010-004-3.21  
Metal Open Rail Gate

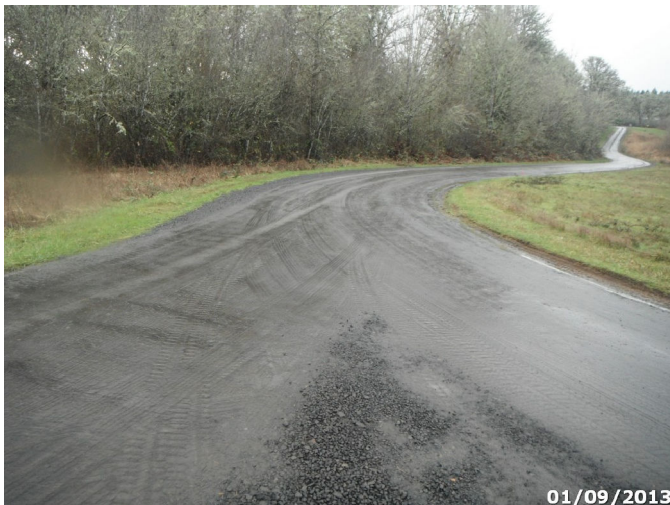
Photo: WIFI\_C4\_0369 Route: 010-005-2.54  
Metal Culvert 25ft long 24in dia. 1ft deep

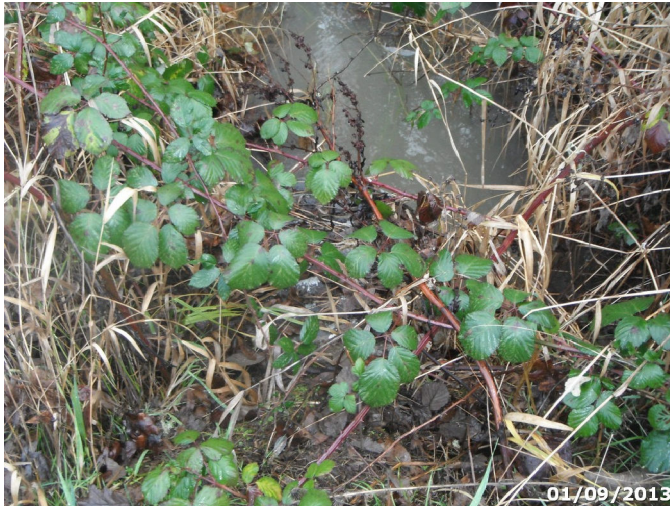
Photo: WIFI\_C4\_0370 Route: 010-005-2.54  
Metal Culvert 25ft long 24in dia. 1ft deep

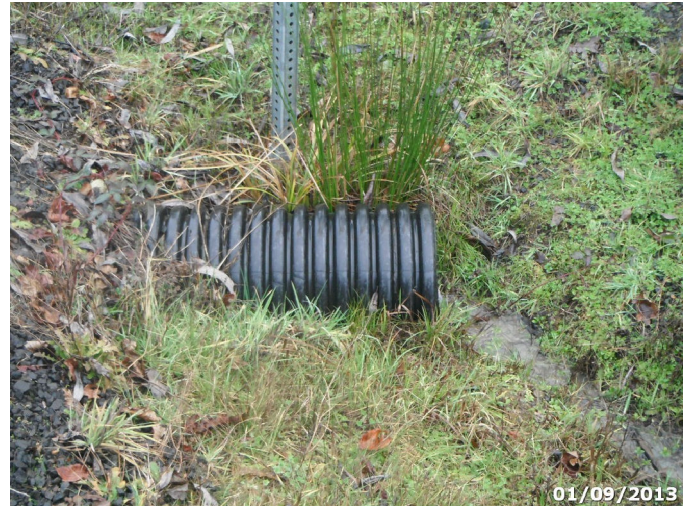
Photo: WIFI\_C4\_0367 Route: 010-005-2.55  
Plastic Culvert 25ft long 12in dia. 1ft deep

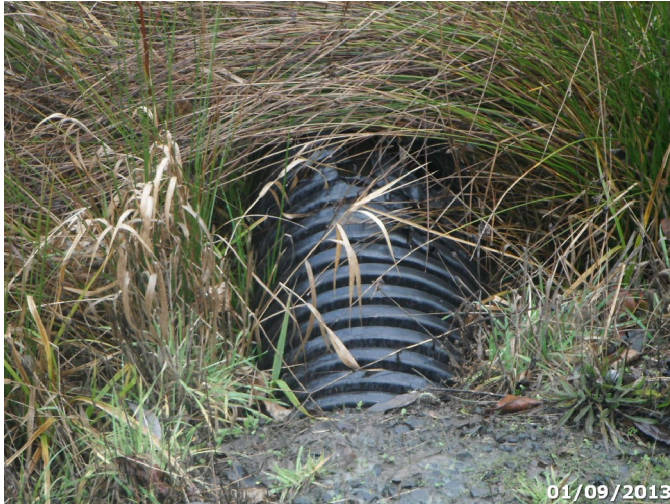
Photo: WIFI\_C4\_0368 Route: 010-005-2.55  
Plastic Culvert 25ft long 12in dia. 1ft deep

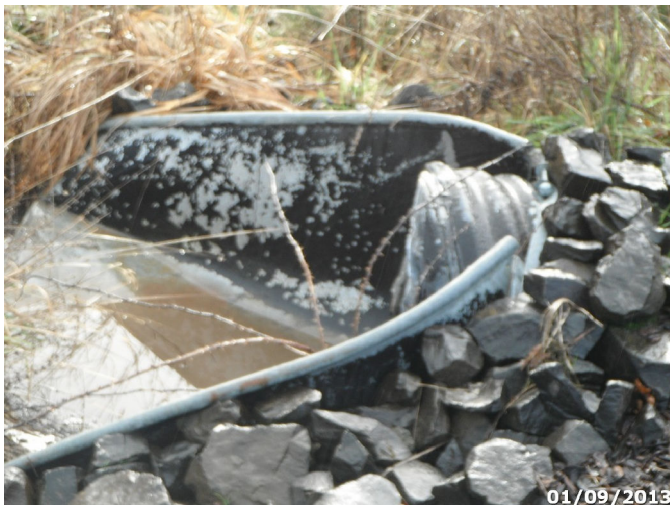
Photo: WIFI\_C4\_0372 Route: 010-006-2.76  
Metal Culvert 30ft long 24in dia. 1ft deep

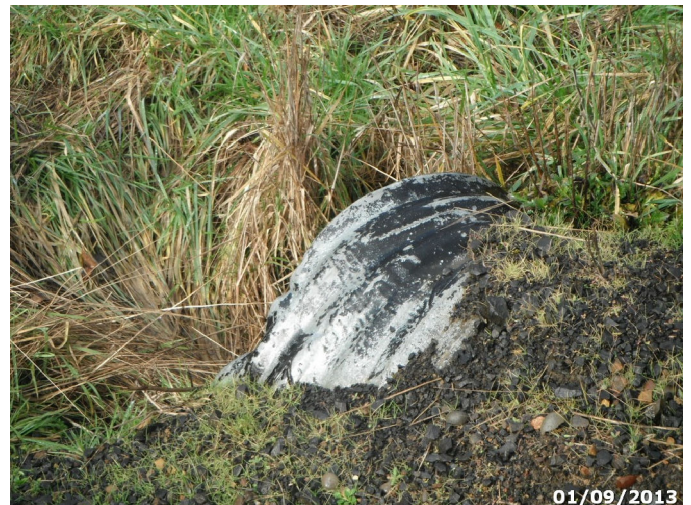
Photo: WIFI\_C4\_0373 Route: 010-006-2.76  
Metal Culvert 30ft long 24in dia. 1ft deep

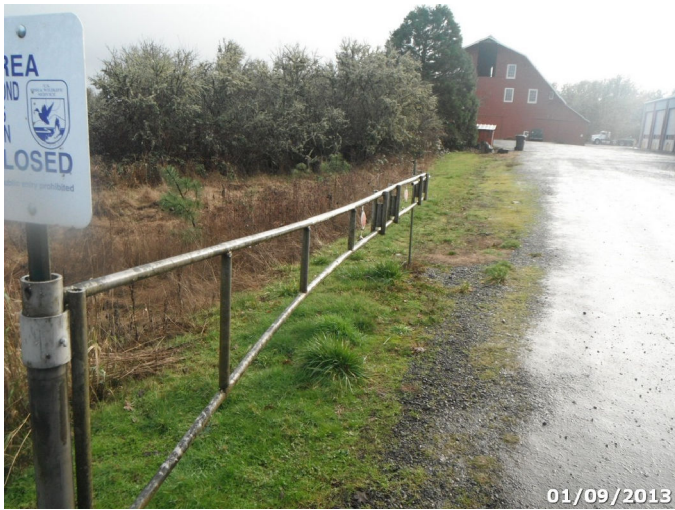
Photo: WIFI\_C4\_0374 Route: 010-006-2.76  
Metal Open Rail Gate

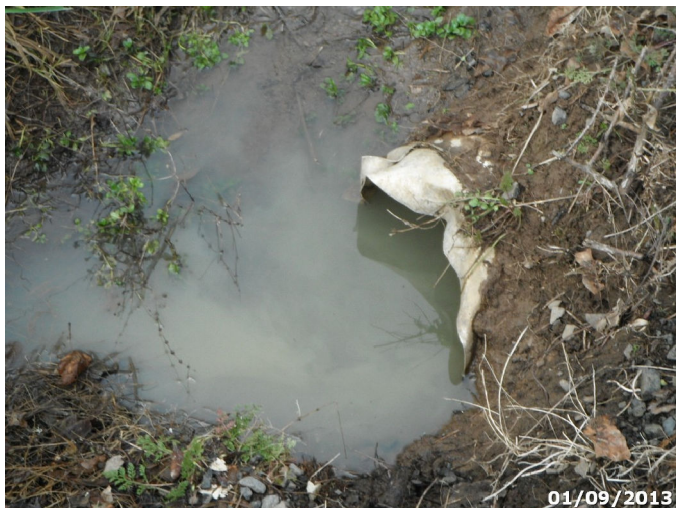
Photo: WIFI\_C4\_0328 Route: 101-001-0.0  
Metal Culvert 50ft long 12in dia. 1ft deep

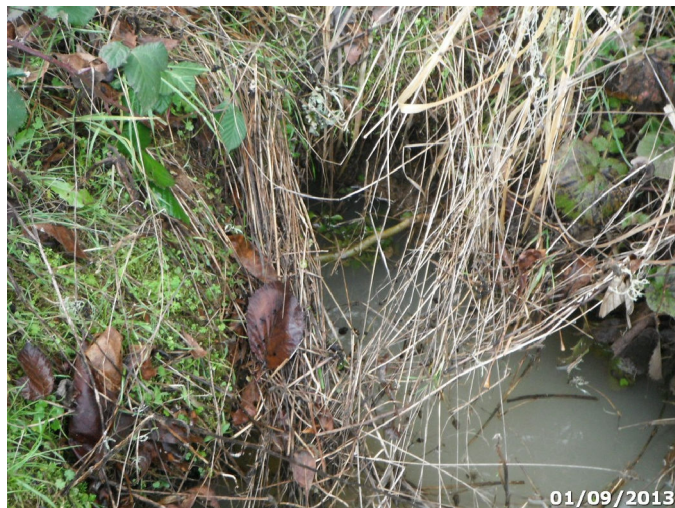
Photo: WIFI\_C4\_0329 Route: 101-001-0.0  
Metal Culvert 50ft long 12in dia. 1ft deep

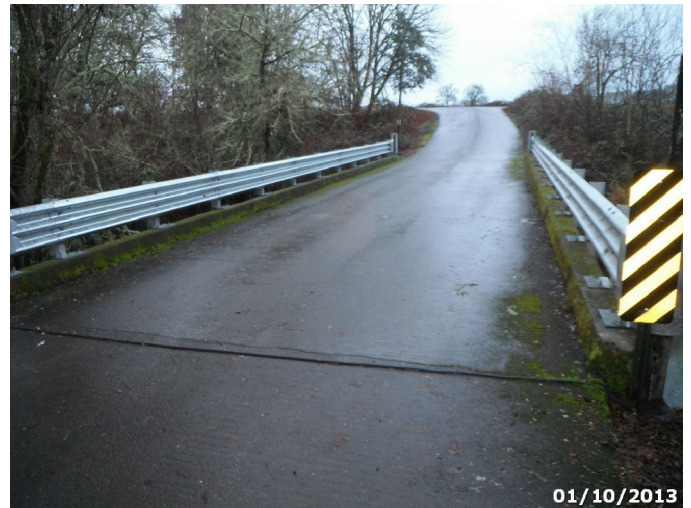
Photo: WIFI\_C4\_0423 Route: 104-001-0.03  
Concrete Bridge NBIS:000013589-0030  
LAKE CREEK Asset# 10059557

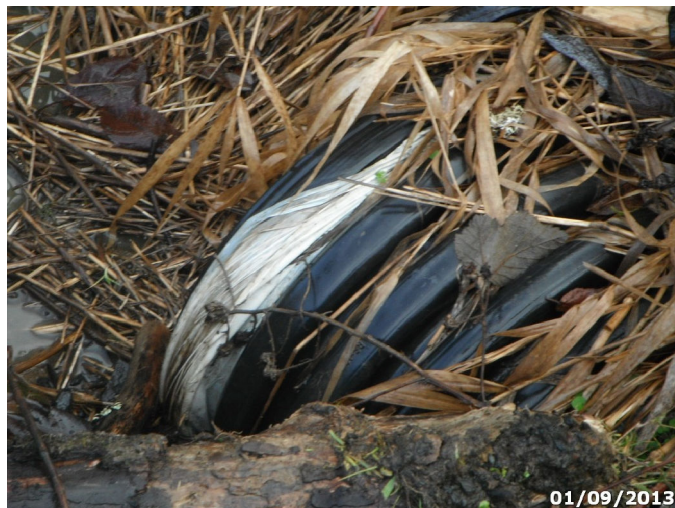
Photo: WIFI\_C4\_0364 Route: 300-001-0.01  
Plastic Culvert 30ft long 18in dia. 1ft deep

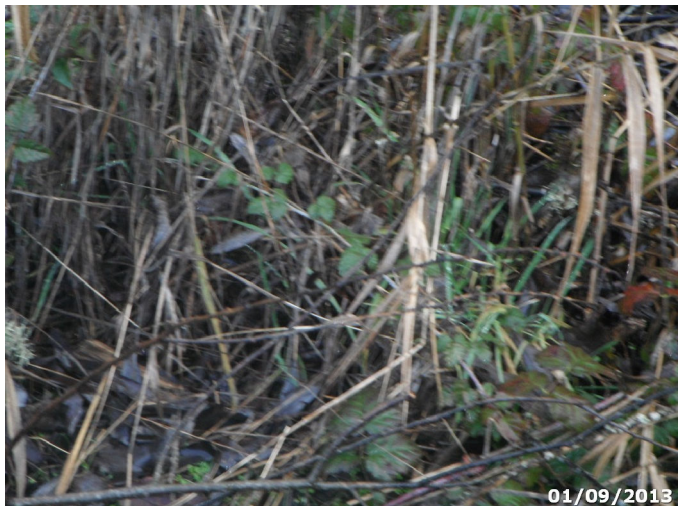
Photo: WIFI\_C4\_0365 Route: 300-001-0.01  
Plastic Culvert 30ft long 18in dia. 1ft deep

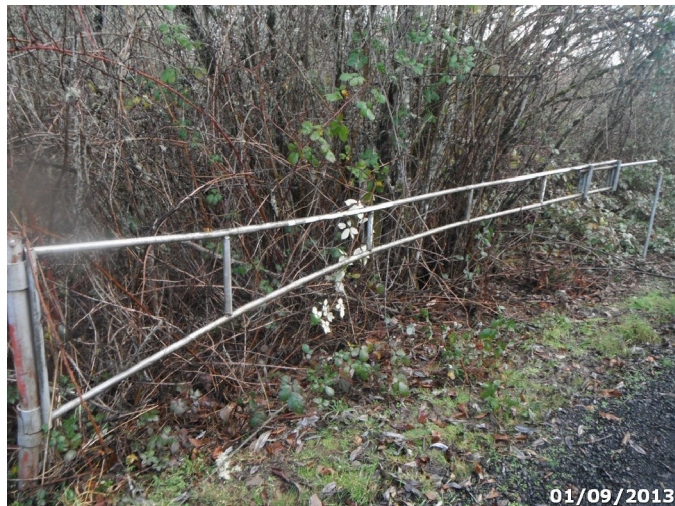
Photo: WIFI\_C4\_0363 Route: 300-001-0.01  
Metal Open Rail Gate

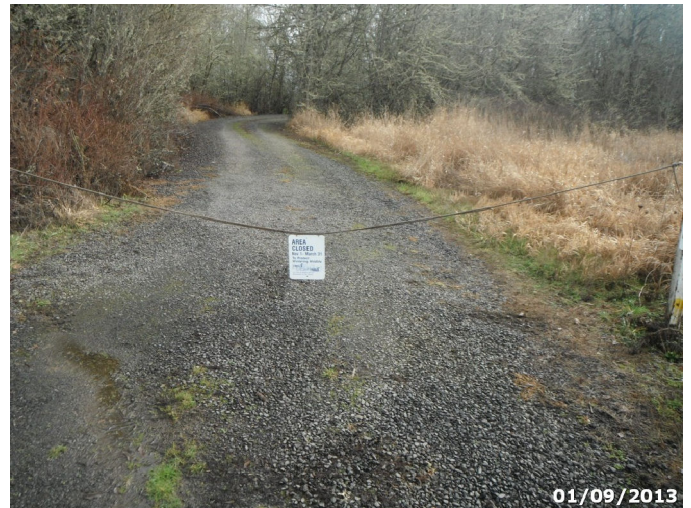
Photo: WIFI\_C4\_0285 Route: 400-001-0.0  
Metal Cable Gate

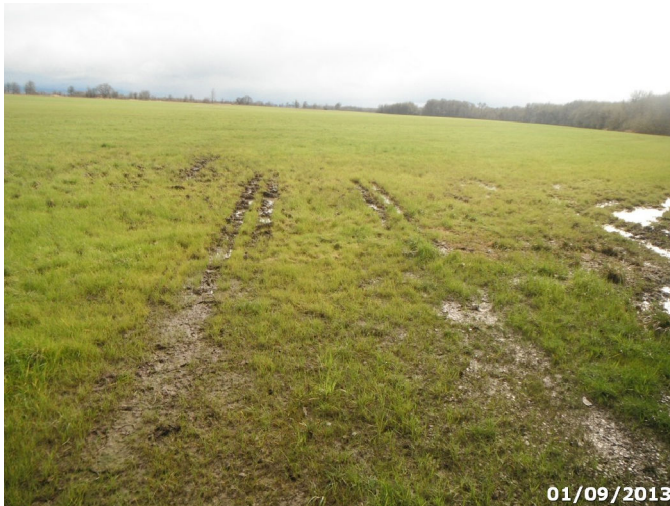
Photo: WIFI\_C4\_0286 Route: 400-001-0.07  
Obstacle Road changes to dirt and is too wet to drive

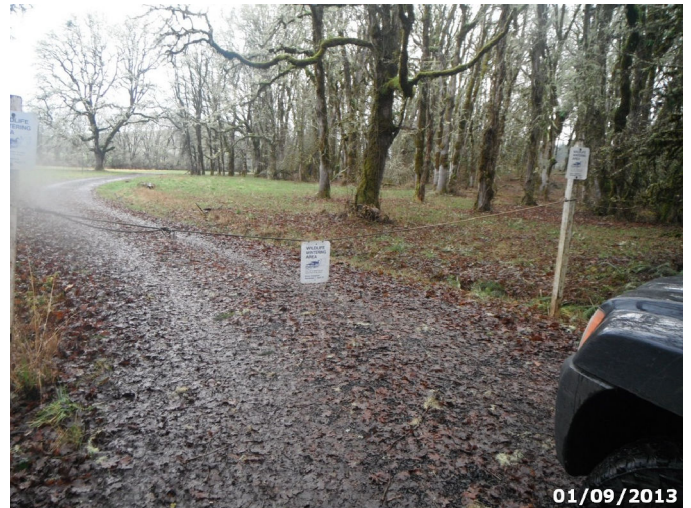
Photo: WIFI\_C4\_0375 Route: 401-001-0.22  
Metal Cable Gate

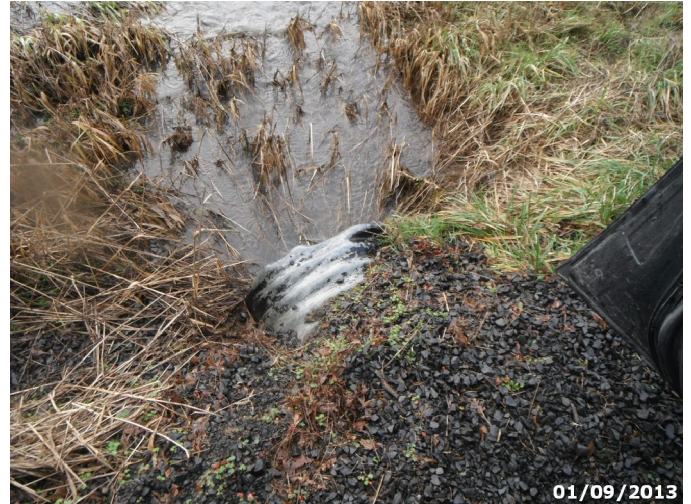
Photo: WIFI\_C4\_0377 Route: 401-002-1.13  
Metal Culvert 20ft long 24in dia. 1ft deep

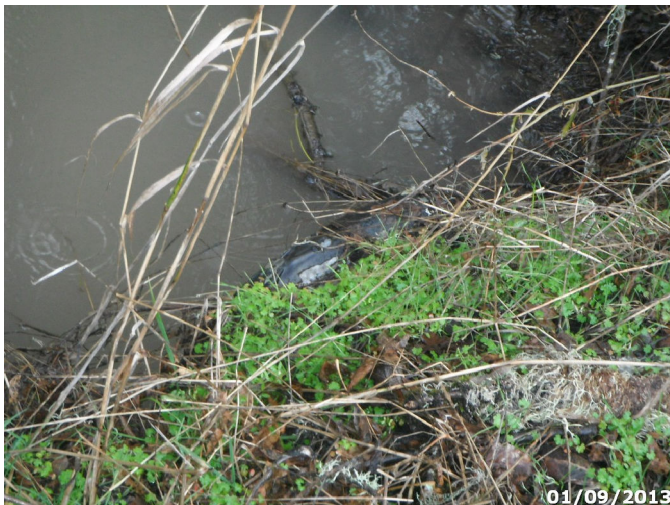
Photo: WIFI\_C4\_0378 Route: 401-002-1.13  
Metal Culvert 20ft long 24in dia. 1ft deep

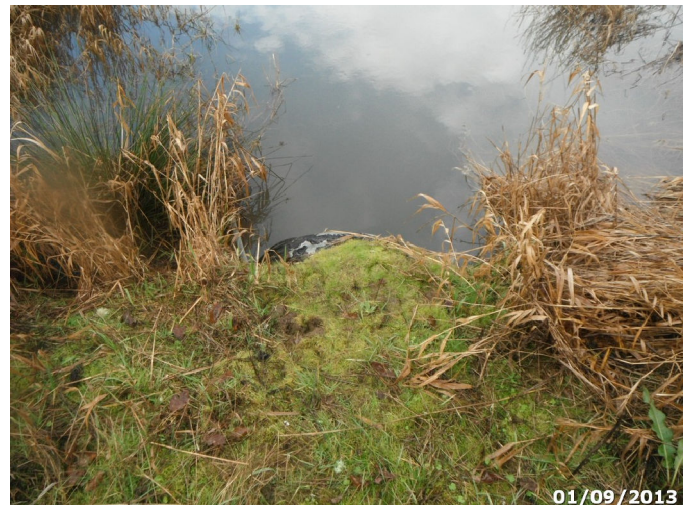
Photo: WIFI\_C4\_0379 Route: 401-002-1.43  
Metal WCS Flashboard Riser  
30ft long 48in dia. 2ft deep

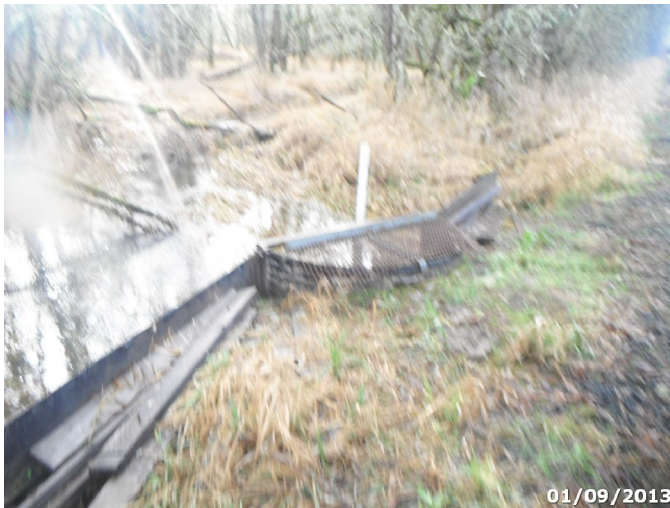
Photo: WIFI\_C4\_0380 Route: 401-002-1.43  
Metal WCS Flashboard Riser 30ft long 48in dia. 2ft deep

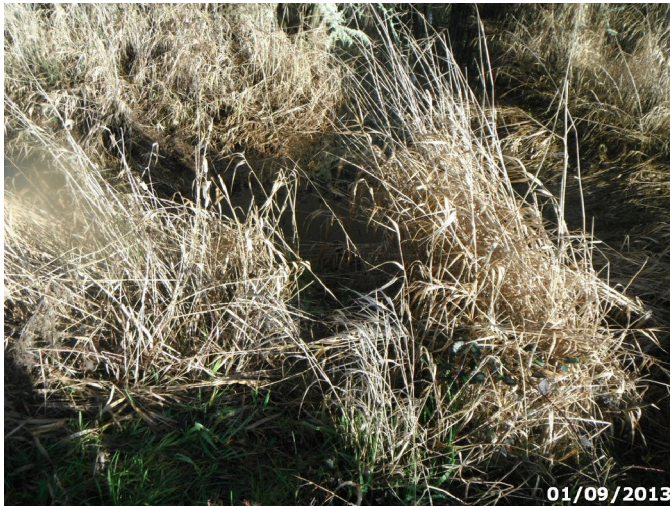
Photo: WIFI\_C4\_0393 Route: 401-003-2.17  
Metal WCS Flashboard Riser 40ft long 24in dia. 3ft deep

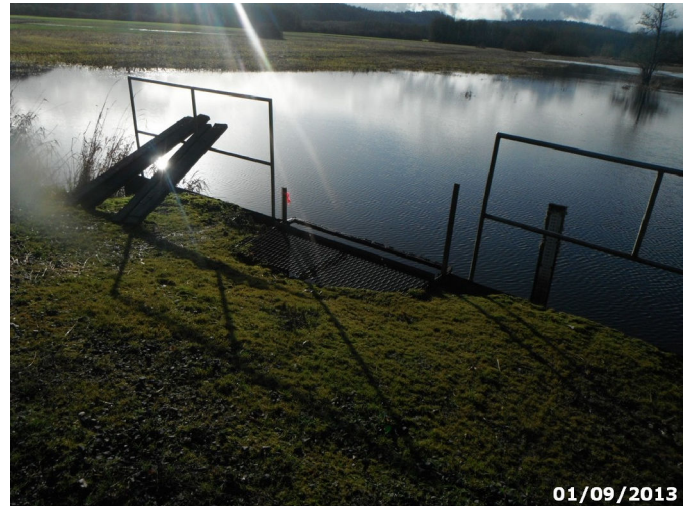
Photo: WIFI\_C4\_0394 Route: 401-003-2.17  
Metal WCS Flashboard Riser 40ft long 24in dia. 3ft deep

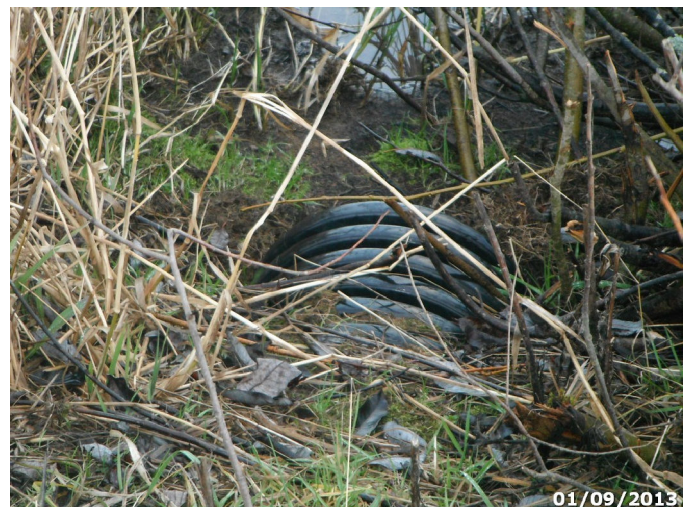
Photo: WIFI\_C4\_0398 Route: 401-004-3.34  
Plastic Culvert 30ft long 18in dia. 2ft deep

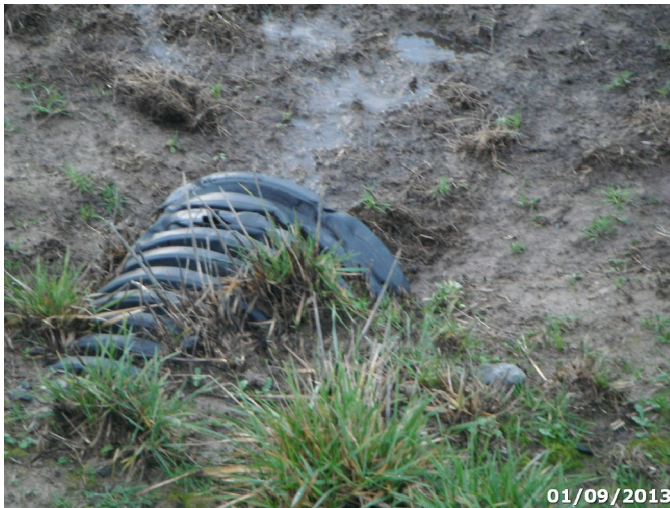
Photo: WIFI\_C4\_0399 Route: 401-004-3.34  
Plastic Culvert 30ft long 18in dia. 2ft deep

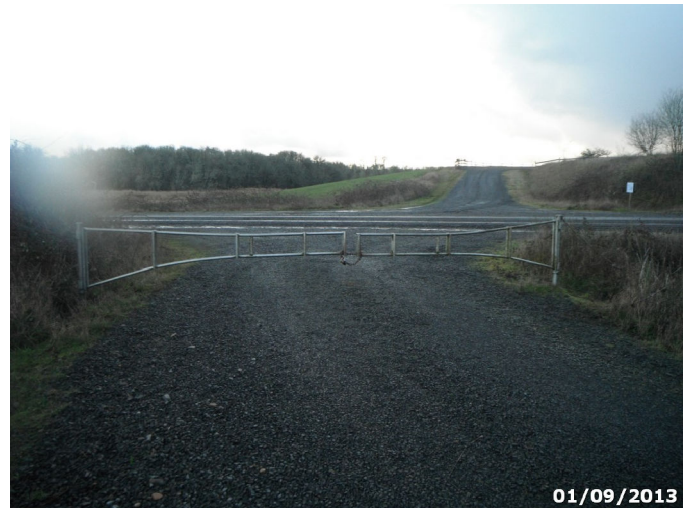
Photo: WIFI\_C4\_0400 Route: 401-004-3.86  
Metal Open Rail Gate

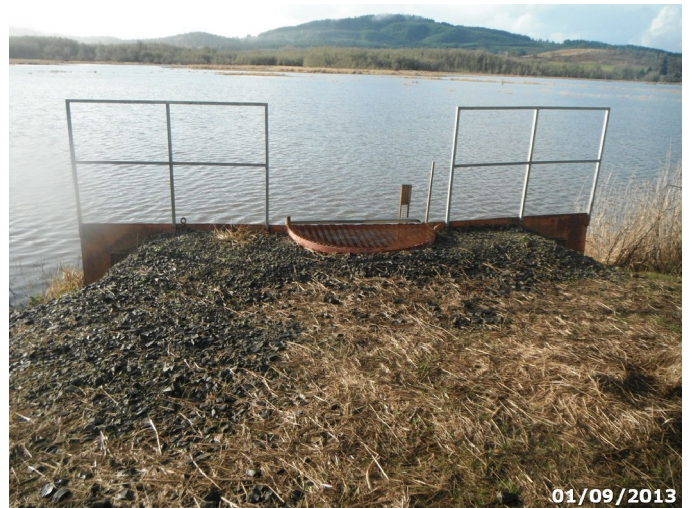
Photo: WIFI\_C4\_0383 Route: 402-001-0.11  
Metal WCS Flashboard Riser 50ft long 48in dia. 2ft deep

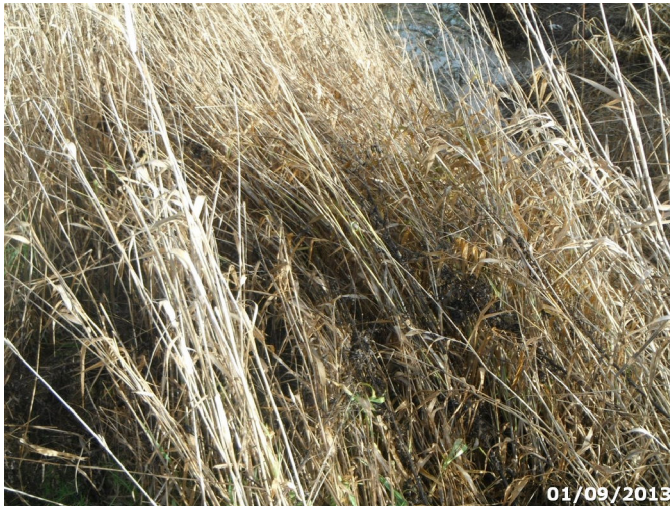
Photo: WIFI\_C4\_0384 Route: 402-001-0.11  
Metal WCS Flashboard Riser 50ft long 48in dia. 2ft deep

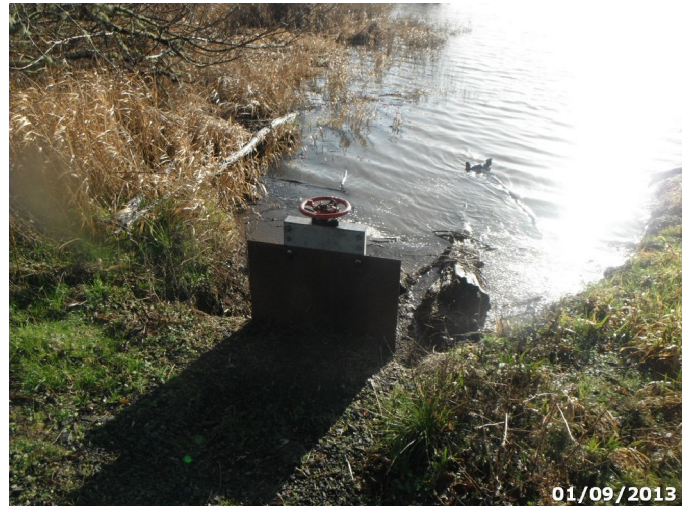
Photo: WIFI\_C4\_0385 Route: 402-001-0.42  
Metal WCS Screw Gate 30ft long 12in dia. 3ft deep

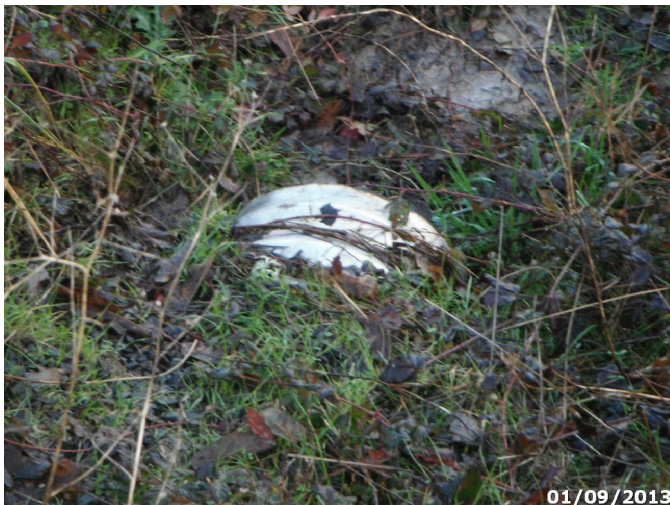
Photo: WIFI\_C4\_0386 Route: 402-001-0.42  
Metal WCS Screw Gate 30ft long 12in dia. 3ft deep

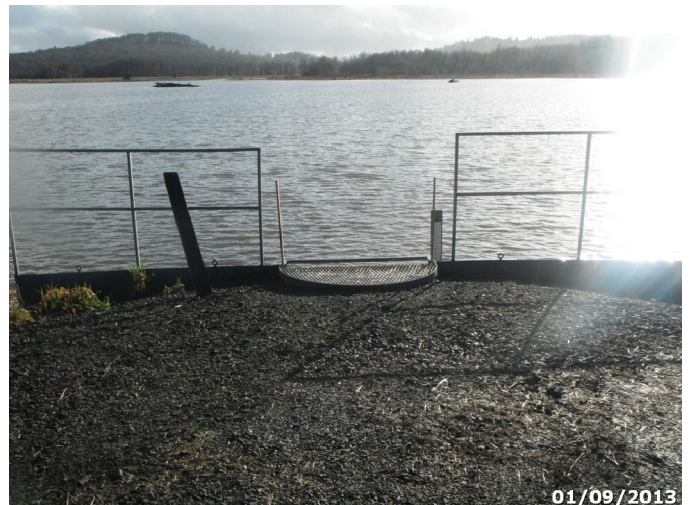
Photo: WIFI\_C4\_0387 Route: 402-001-0.59  
Metal WCS Flashboard Riser 50ft long  
48in dia. 4ft deep

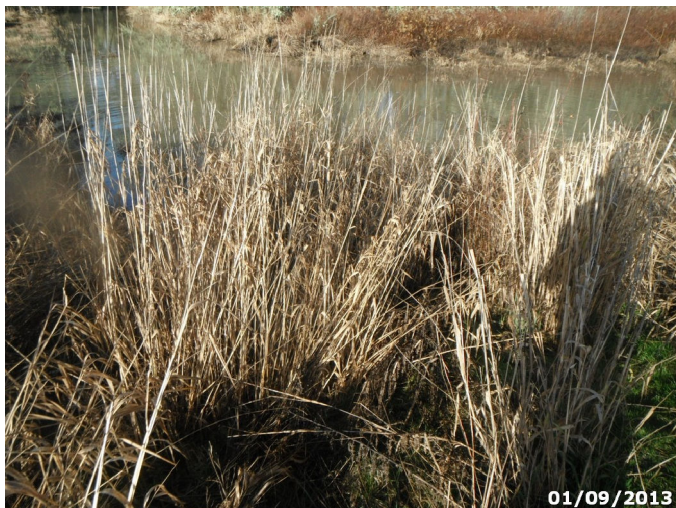
Photo: WIFI\_C4\_0388 Route: 402-001-0.59  
Metal WCS Flashboard Riser 50ft long 48in dia. 4ft deep

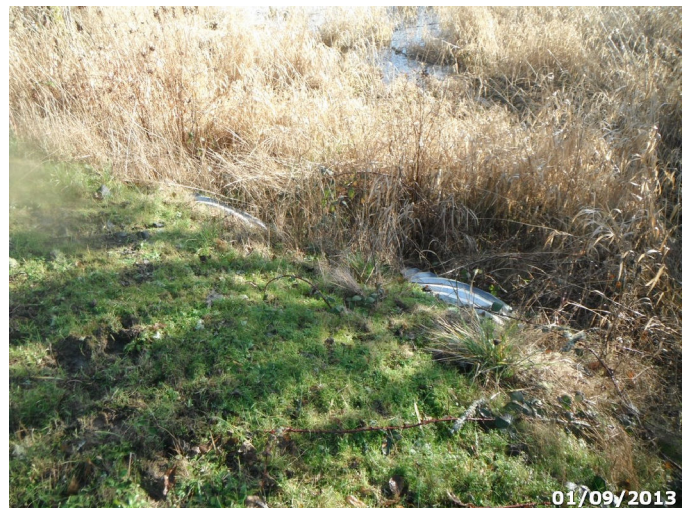
Photo: WIFI\_C4\_0389 Route: 402-001-0.79  
Metal Culvert 40ft long 48in dia. 3ft deep

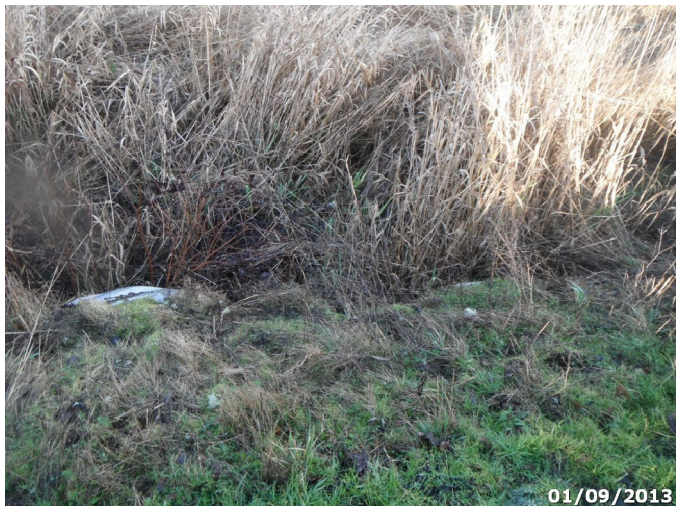
Photo: WIFI\_C4\_0390 Route: 402-001-0.79  
Metal Culvert 40ft long 48in dia. 3ft deep

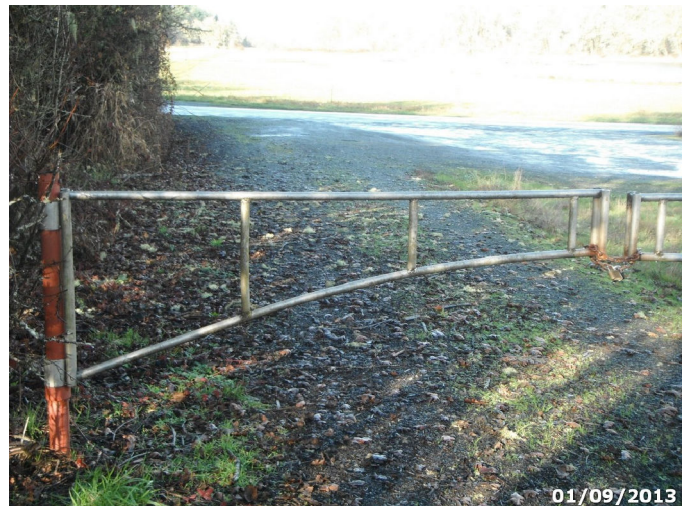
Photo: WIFI\_C4\_0391 Route: 402-001-1.02  
Metal Open Rail Gate

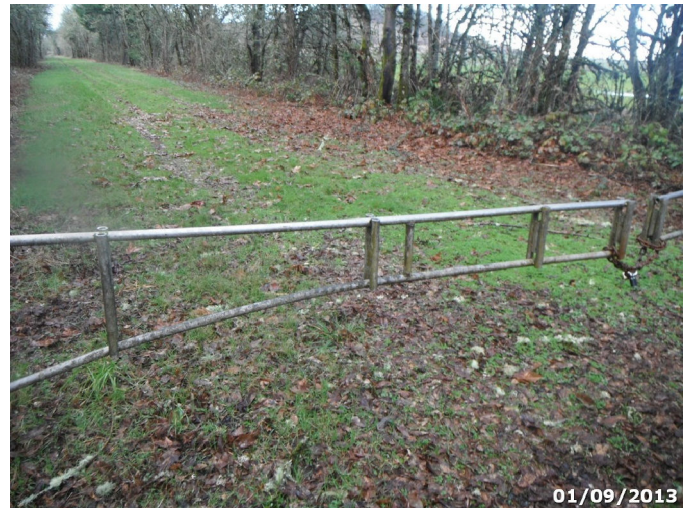
Photo: WIFI\_C4\_0409 Route: 405-001-0.0  
Metal Open Rail Gate
